SERVICE BULLETIN

Classification: FE95-06	Section: Exhaust System	Models:
Reference: TECHNICAL BULLETIN NTB95-025		Date: February 22, 1995

1995 MAXIMA EXHAUST HEAT SHIELD RATTLE NOISE

APPLIED VEHICLE: 1995 Maxima (A32)

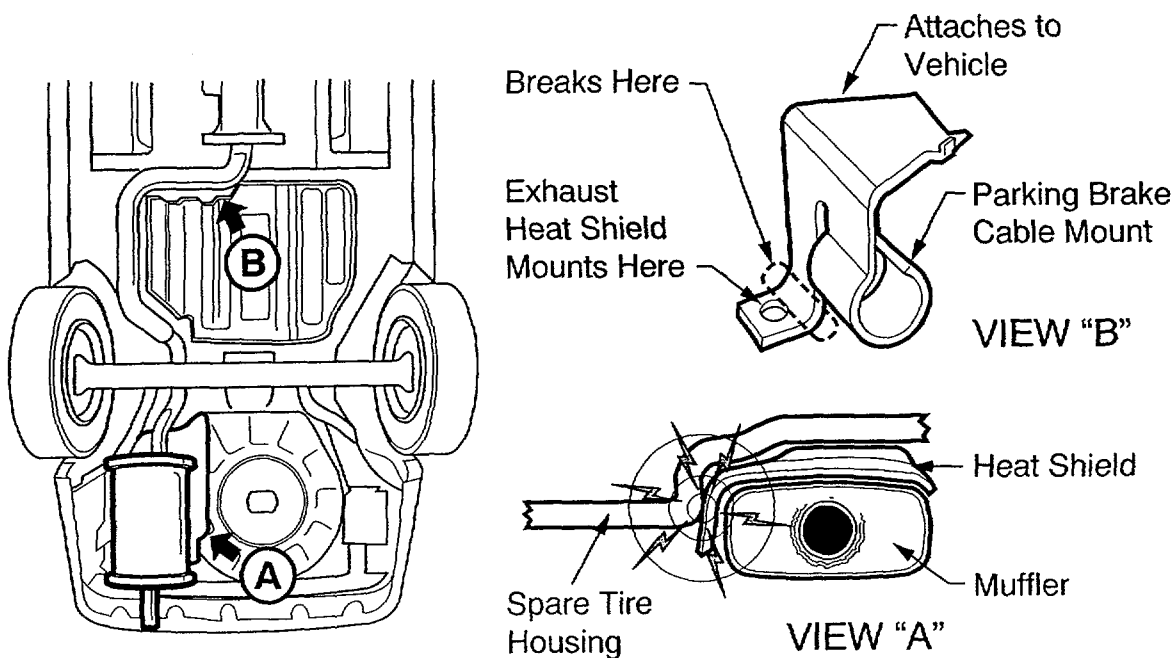
On some 1995 Maxima vehicles there may be a slight rattle noise from the rear of the vehicle when going over bumps. The exhaust heat shield may be contacting the spare tire well or the exhaust heat shield bracket may be broken (Figure 1).

1. Drive the incident vehicle to confirm the rattle noise.
2. Examine the forward exhaust heat shield bracket. If the bracket is broken, replace it. (The bracket may break at the tab where the heat shield mounts.)
3. Bend the rear muffler heat shield to provide adequate clearance from the spare tire well (Figure 2).
4. Road test to confirm the rattle noise is gone.
