# SERVICE BULLETIN

Classification: BT95-003	Reference: NTB95-041	Date: June 7, 1995
-----------------------------	-------------------------	-----------------------

## 1995 MAXIMA SUPPLEMENT RESTRAINT SYSTEM (SRS) FLASHING LIGHT

**APPLIED VEHICLE:** 1995 Maxima (A32)

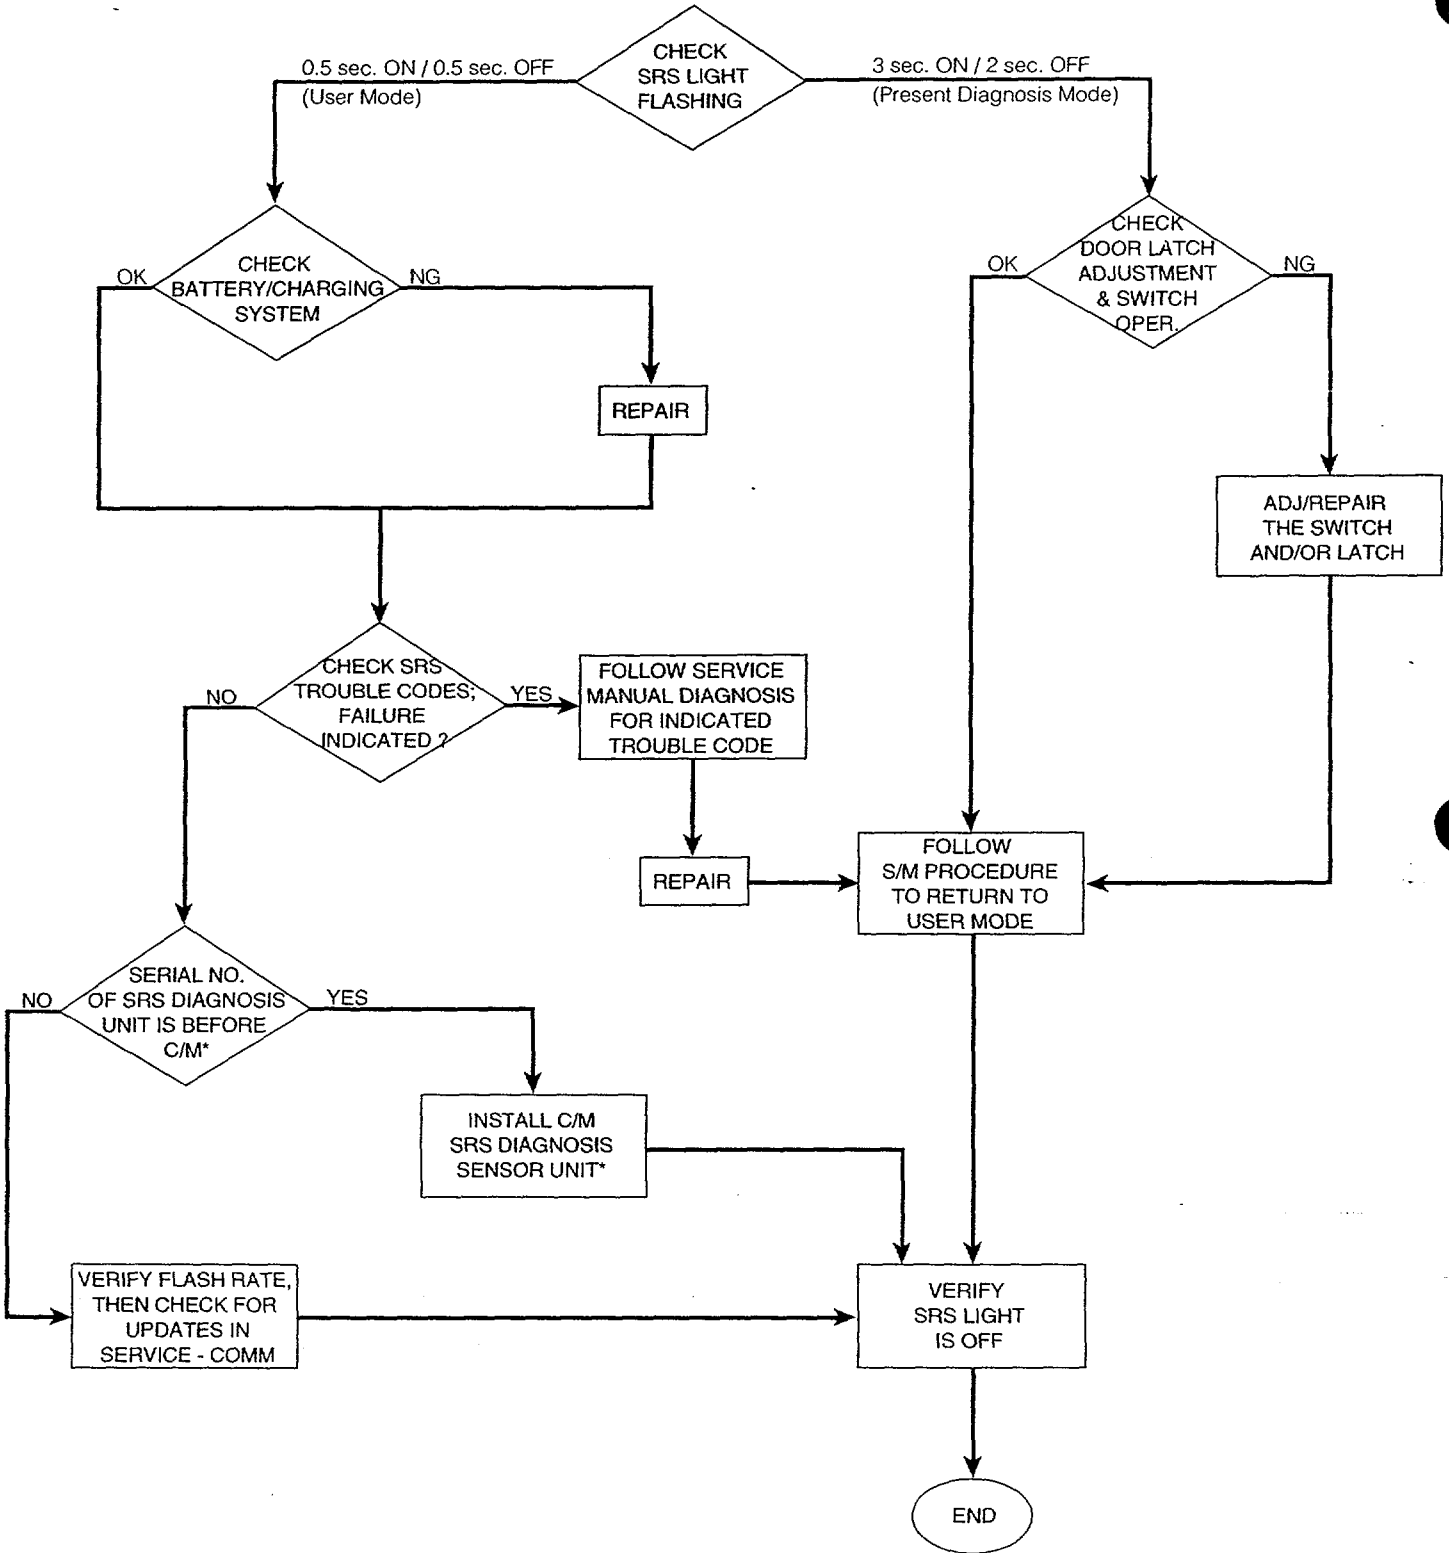
# DIAGNOSTIC FAULT TREE

When diagnosing a blinking SRS warning light (with a blinking frequency of 0.5 seconds on/0.5 seconds off *or* 3 seconds on/2 seconds off), the attached diagnostic fault tree should be followed especially when CONSULT indicates no failure detected.

\*C/M Serial No. of production SRS DIAGNOSIS SENSOR UNIT begins with SE41U946170022 (~August 1994)  
 C/M Serial No. of service SRS DIAGNOSIS SENSOR UNIT begins with SE41U948240424

If vehicle already has C/M Diagnosis Sensor Unit, check for updates in SERVICE-COMM
