SERVICE BULLETIN

Classification: EC95-009	Reference: NTB95-045	Date: May 3, 1995
-----------------------------	-------------------------	----------------------

OBD-II ECM CONNECTOR BOLT

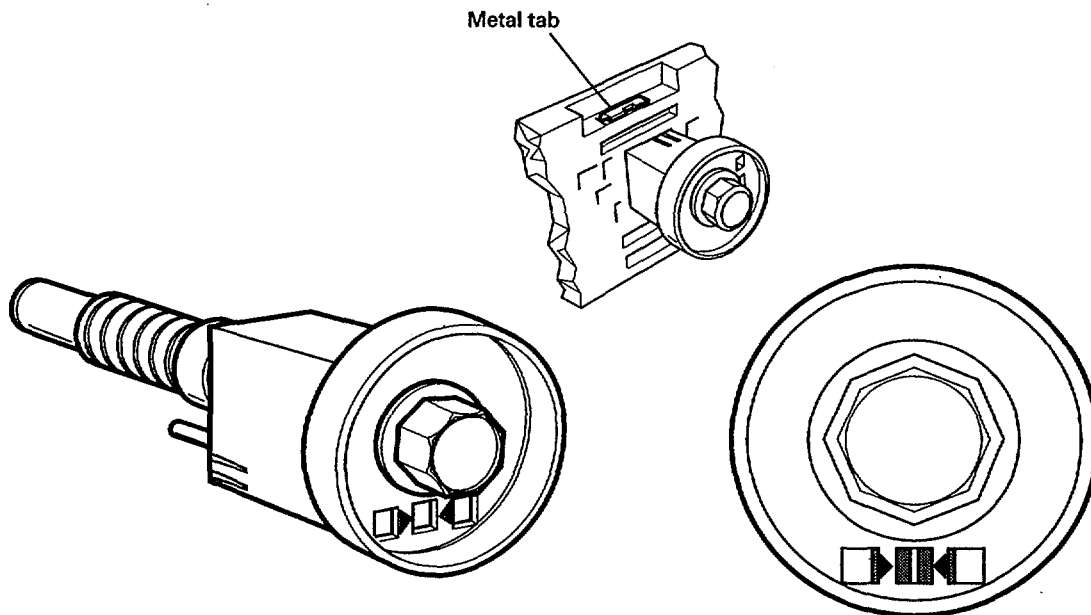
OBD-II equipped vehicles have a new style ECM connector which attaches with a new type of bolt. This bolt has a black plastic sleeve that retains an orange pin. The pin indicates that the connector is tight when it appears as an orange square between the two triangular indicators next to the bolt.

The correct tightening torque for the ECM connectors bolts is 30-50 Kg-cm (23-43 in-lb). If a bolt is broken while disconnecting the harness from the ECM, the bolt must be replaced. The bolt is attached to the connector shell by a sliding metal tab above the bolt. To remove the bolt gently pry the tab upward about 1/8" and pull the bolt out of the connector. The bolt is available as a service part. The portion of the bolt that remains in the ECM should be removed with a suitable tool.
