# SERVICE BULLETIN

AT95-004

October 4, 1995

## 1995-1996 MAXIMA A/T KEY INTERLOCK CABLE

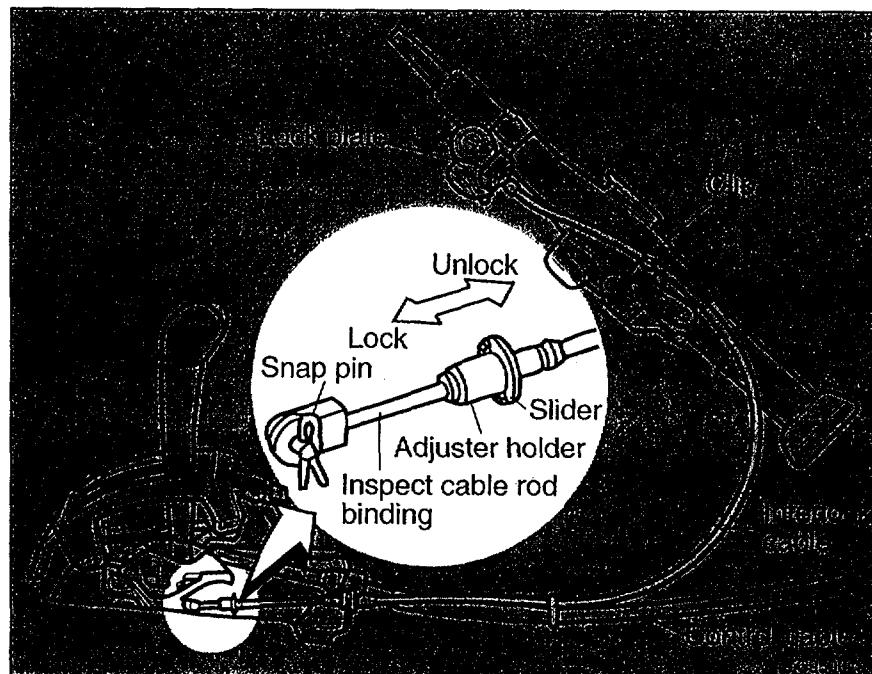
Customers may complain that the automatic transmission shift lever cannot be moved from Park under hot ambient conditions. The incident may occur more frequently when the vehicle is parked in direct sunlight. A new A/T interlock cable has been developed to reduce internal friction under hot ambient conditions.

3. If the incident is resolved in step 1, reconnect the interlock cable to the shifter and disconnect it from the ignition key. **If the incident returns**, the cable may be damaged and/or have excessive internal friction.
4. Replace the A/T key interlock cable with the part number listed in this bulletin. Refer to pages AT-122 in the 1995 Maxima Service Manual and A/T-121 & 122 in the 1996 Maxima Service Manual for proper cable removal, installation, and adjusting procedures.
5. Recheck interlock cable operation under the same ambient temperature conditions that the incident originally occurred.

1. After duplicating the incident, isolate whether the shifter or interlock cable is the cause of the incident. Disconnect the interlock cable from the shifter. If this does **not** resolve the incident, the problem is in the shifter.
2. Check for proper shifter solenoid operation, bent/broken parts, and evidence of spilled liquids (juice or soda). Repair/clean components as necessary and recheck operation.

**Do not** twist the adjuster holder when performing the cable adjustment. Twisting of the adjuster holder can increase internal friction of the cable and increase the risk of the shifter becoming stuck in park.

After cable replacement, ensure that the shifter **cannot** be moved after the key has been removed from the ignition. If the shifter can be moved without the key in the ignition, lengthen the cable adjustment and recheck.
