SERVICE BULLETIN

Classification: AT96-002	Reference: NTB96-007	Date: February 21, 1996
------------------------------------	--------------------------------	-----------------------------------

RE4F04A AUTOMATIC TRANSMISSION (A/T) - DIFFERENTIAL PINION SHAFT WORN

APPLIED VEHICLES: 1992-1994 Maxima (J30 -VE30DE engine)
1995-1996 Maxima (A32)
1993-1996 Altima (U13)
1994-1996 Quest (V40)

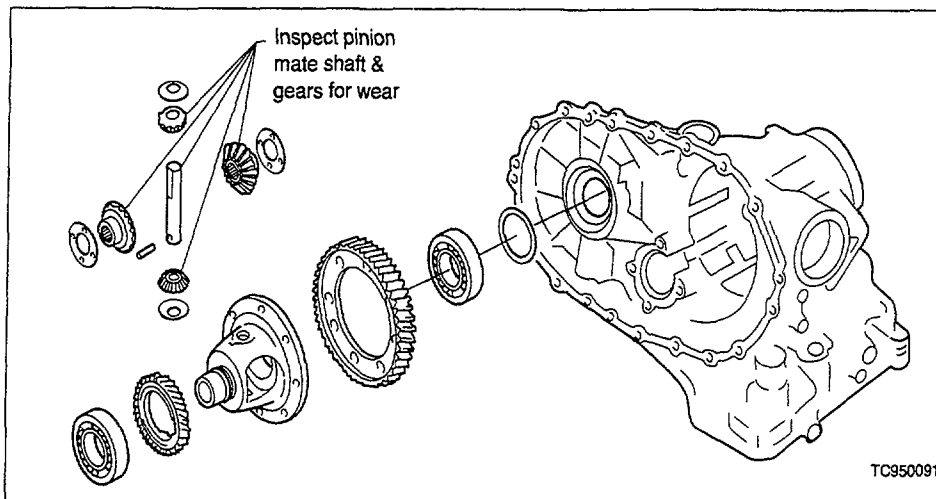
Debris from a worn differential pinion mate shaft can cause the following:

- Slipping on acceleration
- Hesitation and/or stalling when cold
- Abnormal noise coming from the transmission while driving

1. Verify the customer's complaint. If the transmission exhibits slipping on acceleration, hesitation and/or stalling when cold, or any abnormal noises coming from the transmission while driving, and no trouble codes are found in self-diagnosis, remove the transmission oil pan and inspect for metal debris.
2. If excessive metal debris is found, disassemble the transmission and inspect for burnt or worn components. If wear marks are found on the differential pinion mate shaft, (refer to Figure 1 on the following page), replace the shaft and install a countermeasure differential case P/N 38411-81X01. Replace all other burnt or worn components as necessary.
