SERVICE BULLETIN

| Classification: AT96-005 | Reference: NTB96-045 | Date: April 17, 1996 |

1995 MAXIMA AUTOMATIC TRANSMISSION (A/T) SHIFTER STICKING FROM SPILLED LIQUID

| APPLIED VEHICLE: | 1995 Maxima (A32) |

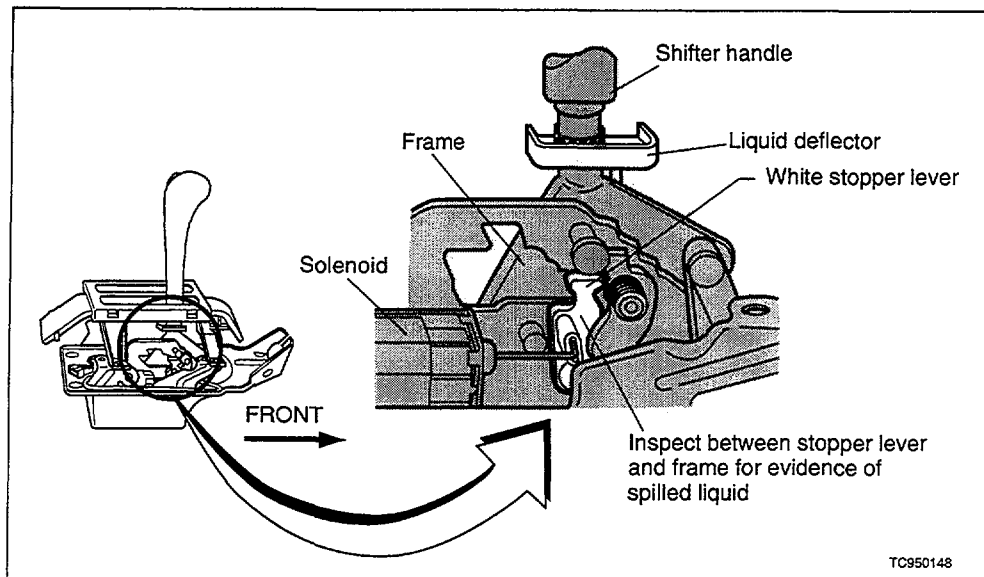
Figure 1

The A/T shifter may intermittently stick in the "Park" position. This incident may be caused by spilled liquids such as juice or soda coming in contact with the shift interlock mechanism. A countermeasure shifter control device, finisher, and cupholder are available to guide any liquids away from the shift interlock mechanism. These countermeasure parts have been installed during production on all Maximas beginning February 1, 1995.

1. Verify that all A/T shift components of the shift interlock system are functioning properly by following the diagnostic procedures on pages AT-118 to AT-121 in the 1995 Maxima Service Manual.
2. Verify the proper routing and installation of the key interlock cable by following the procedure on page AT-122 in the 1995 Maxima Service Manual.
3. Perform the shift lock solenoid component check as described on page AT-124 in the 1995 Maxima Service Manual. If the solenoid "clicks", but the white stopper lever doesn't move to the forward position, inspect the area for evidence of spilled liquid, as shown in Figure 1. If any evidence of spilled liquid is found, install the appropriate countermeasure A/T shift control device listed on page 2 of this bulletin.

4. Adjust the key interlock cable as shown on page AT-122 of the 1995 Maxima Service Manual.
5. Verify proper operation of the shift interlock mechanism.
6. Install a countermeasure finisher using the appropriate part listed in the table below.
7. Install the appropriate countermeasure cupholder/divider listed in the table below using double stick foam tape.
