SERVICE BULLETIN

AT96-003b

RE4F04A AUTOMATIC TRANSMISSION (A/T) - WILL NOT SHIFT WHEN PLACED IN REVERSE

APPLIED VEHICLES: 1993-1996 Quest (V40)
1992-1994 Maxima SE (J30)
1995-1996 Maxima (A32)
1993-1996 Altima (U13)

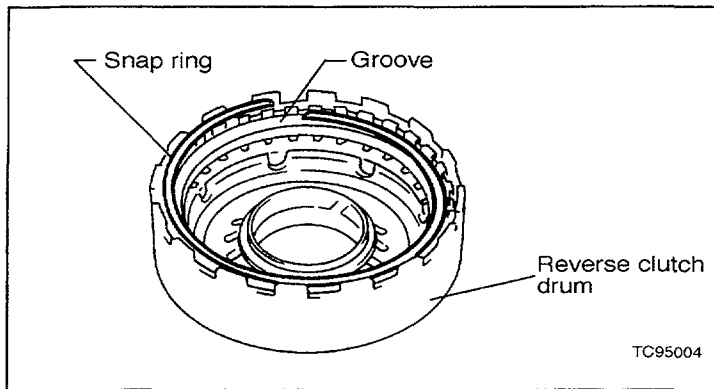
Figure 1

The reverse clutch drum snap ring may pop out of the inner drum retaining groove to cause this incident. A countermeasure reverse clutch drum, snap ring, and 2 dish plates have been developed to resolve this incident.

3. Perform a line pressure test using Kent-Moore J34301-C A/T pressure gauges. If the snap ring has popped out (refer to Figure 1), the line pressure in reverse will be low or zero.

4. If the line pressure is low or zero, remove the reverse clutch drum and inspect the snap ring and retaining groove. If the snap ring has popped out, replace the snap ring using the part number on the following page. If the reverse clutch inner drum retaining groove shows signs of wear, replace the reverse clutch drum using the part numbers listed on the following page.
