SERVICE BULLETIN

AT97-001

April 16, 1997

DIAGNOSTIC PROCEDURE FOR P0731, P0732 & P0733 (A/T SIGNALS) WITH NO DRIVEABILITY INCIDENTS

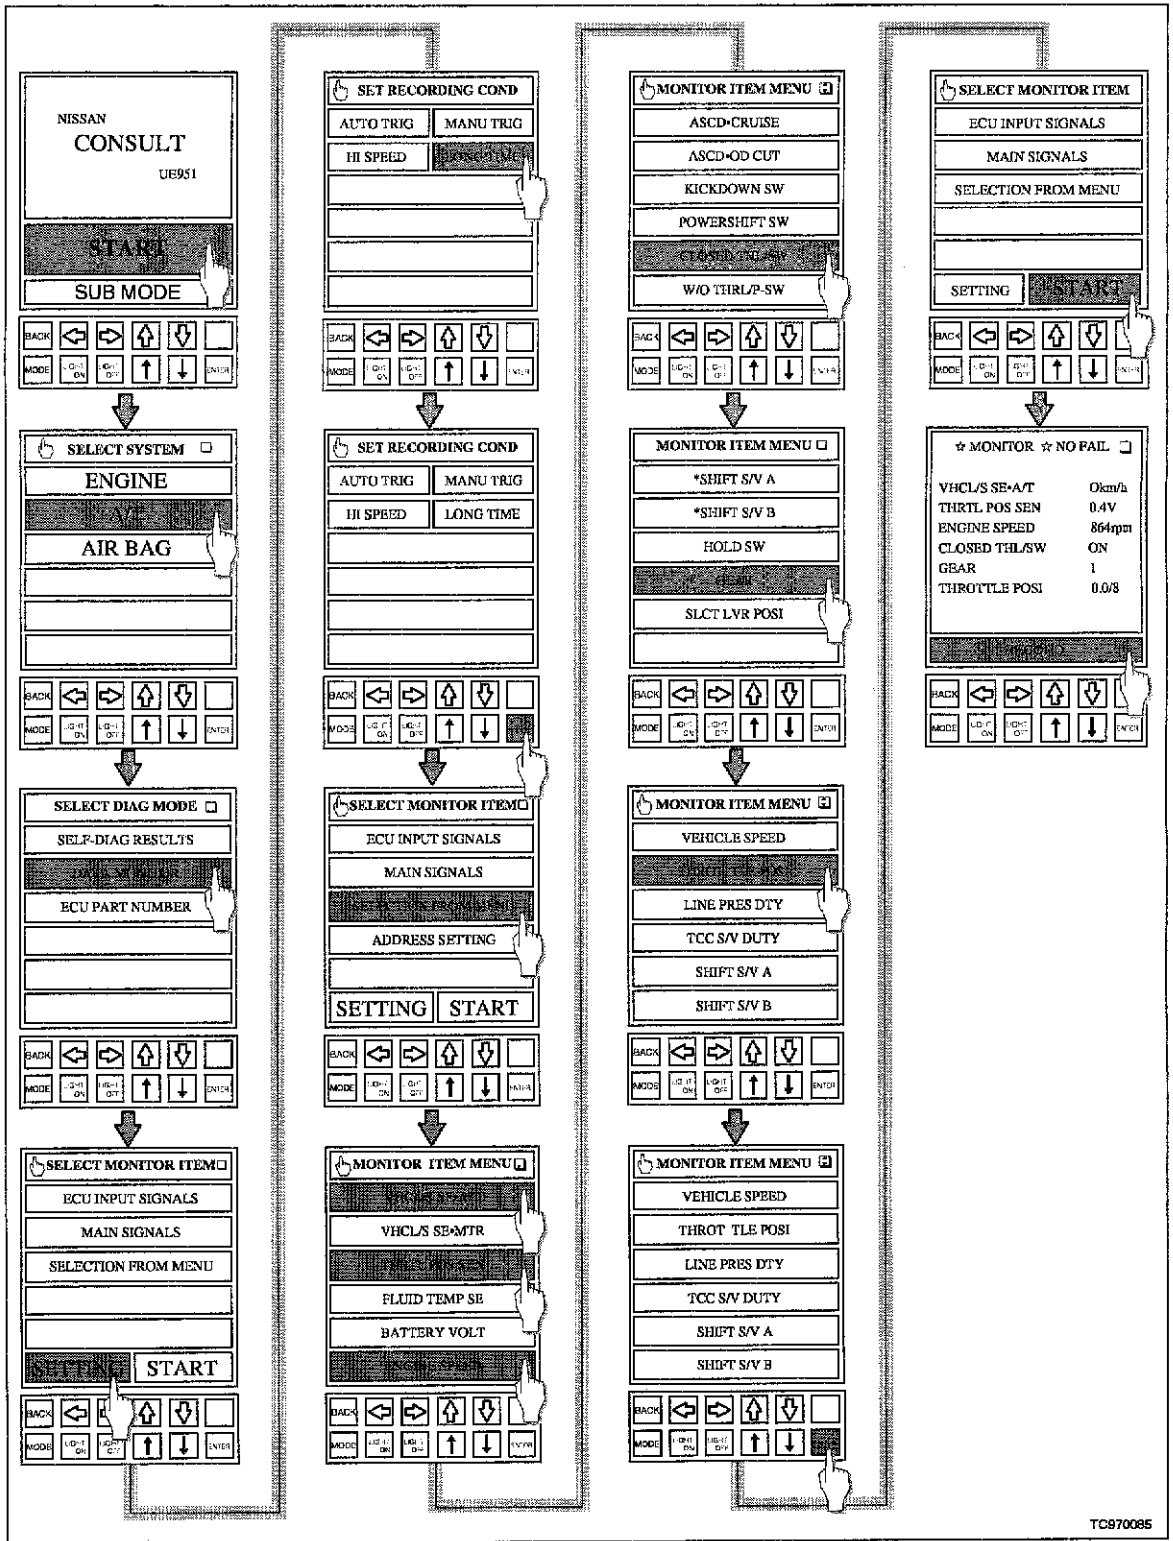
Figure 1

1. Connect CONSULT. Confirm the throttle position sensor (TPS) setting is correct as follows:
2. Bring the engine to normal operating temperature.
3. Select A/T, then DATA MONITOR then SELECTION FROM MENU (see Figure 1, next page).
4. Select VHCL/S SE A/T, THRTL POS SEN and ENGINE SPEED.
5. Then select CLOSED THL/SW, GEAR, THROTTLE POSI and VEHICLE SPEED.
Press ENTER to save these selections.
6. Press Settings and select HI SPEED/MANU TRIG. Press START and watch the data.
