SERVICE BULLETIN

BR97-001

1995-97 MAXIMA PARKING BRAKE CABLE DAMAGE

APPLIED VEHICLE: 1995-97 Maxima (A32)

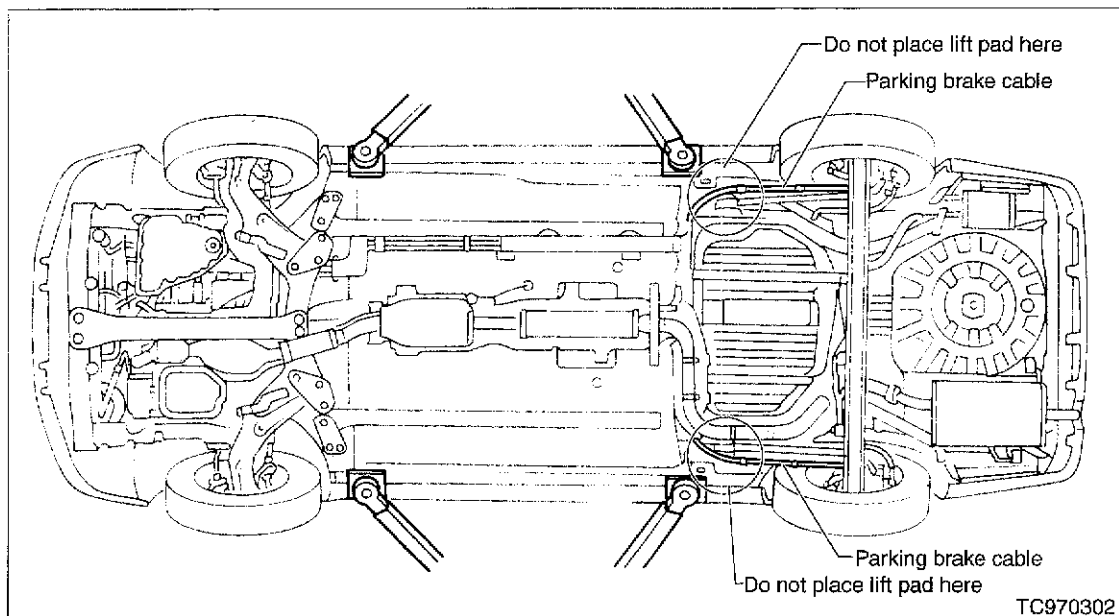
If the hoist arm is improperly positioned on the rear trailing arm/mount area of a 1995-97 Maxima, the parking brake cable can be torn or pinched.

If this occurs, difficulties with the parking brake cable operation may result.

To eliminate this possibility, use proper rear lift locations as shown.

CAUTION: Put the sill in the groove of the lift pad to prevent the sill from deforming. If the pad does not have a groove, prepare a suitable attachment with one. For 1995 & 1996, refer to the service manual pages GI-37 and GI-39. For 1997, refer to the service manual pages GI-39 and GI-41.
