SERVICE BULLETIN

Classification: EC97-027	Reference: NTB97-058	Date: August 13, 1997
-----------------------------	-------------------------	--------------------------

1995-97 MAXIMA SPARK KNOCK

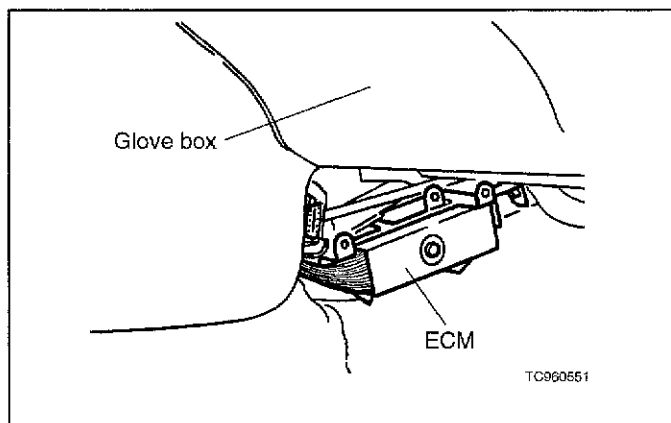
Figure 1

Follow the procedure contained in this bulletin to diagnose and repair 1995-97 Maxima vehicles if spark knock is heard especially when operating in high ambient temperature/low humidity conditions.

3. If the customer is using premium unleaded gasoline and the EGR system is operating normally, replace the ECM (see Figure 1) with the appropriate countermeasure part listed in the Parts Information table on page 2.

Before replacing the ECM, see steps 1 through 4 of the PRECAUTIONS AND PREPARATION section, page EC-5 of the service manual.
