# SERVICE BULLETIN

Classification: FA97-002	Reference: NTB97-067	Date: September 24, 1997
-----------------------------	-------------------------	-----------------------------

## 1995-97 MAXIMA FRONT SPRING UPPER WINDING RATTLE NOISE

**APPLIED VEHICLE:** 1995-97 Maxima (A32)  
**APPLIED VIN(S):** Vehicles built before JN1CA21D2VT852639,  
JN1CA21D7VT218405, JN1CA21D\*VM524078  
**APPLIED DATE:** Vehicles built before March 1997

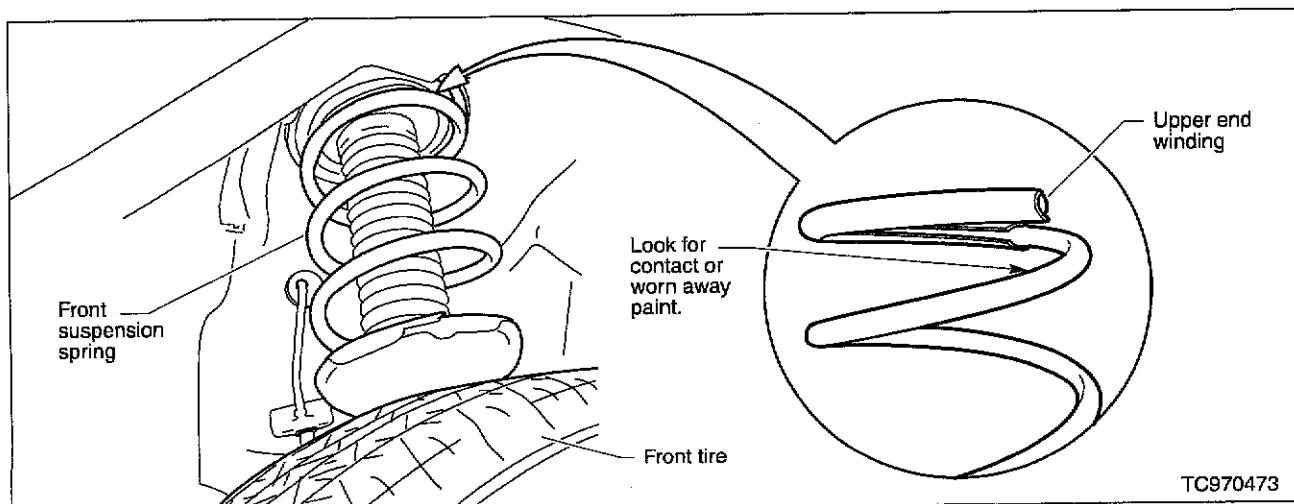
Figure 1  
1/2

If a 1995-97 Maxima exhibits a rattle noise in the front suspension when driving on bumpy roads, the front spring upper coil may be contacting the upper end winding of the spring and causing the rattle noise.

1. Using the following steps, confirm the rattle noise is coming from the front suspension and occurs under the same conditions described above.
  - A. Listen for a rattle noise in the front suspension when driving the vehicle over a series of small bumps. It is advisable to use an electronic listening device (such as "Chassis Ears"<sup>TM</sup>) placed near the upper front suspension springs during the test drive.
  - B. With the vehicle on a lift/hoist, visually inspect the front suspension springs for evidence of contact or worn away paint between the upper end winding and the coil just below it (see Figure 1).

2. If the noise, contact or worn away paint is confirmed, replace both front strut springs with the countermeasure springs. Refer to the service manual (FA section) for the replacement procedure.
