SERVICE BULLETIN

Classification: BT97-017	Reference: NTB97-089	Date: January 1, 1998
-----------------------------	-------------------------	--------------------------

1995-97 MAXIMA INTERIOR SQUEAK AND RATTLE REPAIR

APPLIED VEHICLE: 1995-97 Maxima (A32)
APPLIED VINS: Vehicles built before the VINs from the table below
APPLIED DATES: Vehicles built before the C/M dates from the table below

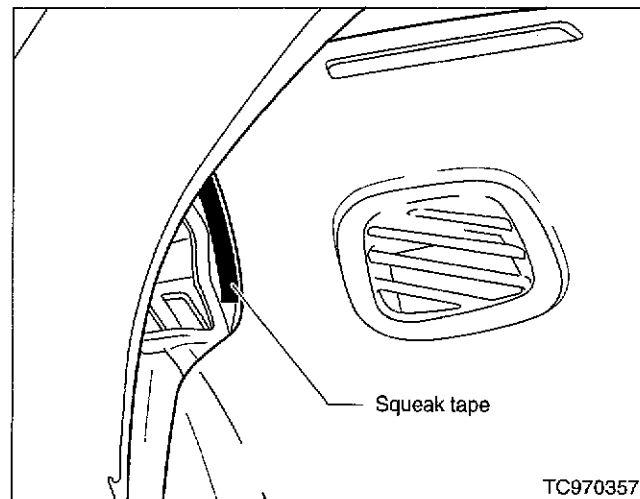
Figure 1

Item	Incident Part	Incident Description	Production C/M Date/VIN	Repair Method
1	A-pillar finisher (either side). GXE & SE models only	Bottom of A-pillar finisher contacts the end of the instrument panel pad.	October 28, 1996 VT218424, VT85288, VM523239	Remove the A-pillar finisher. Add squeak tape to the end of the instrument panel as shown (see Figure 1). Replace the A-pillar.

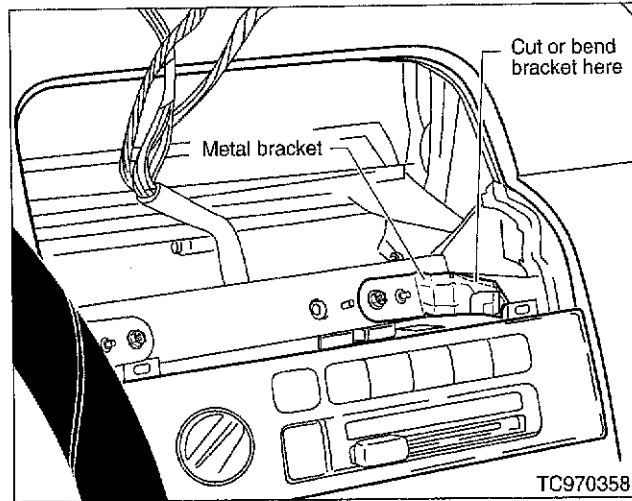
Figure 2

Item	Incident Part	Incident Description	Production C/M Date/VIN	Repair Method
2	Hazard warning switch	The switch may contact the metal bracket for the HVAC/audio head units.	April 25, 1997 VT860216, VT219864, VM527418	Remove the HVAC/audio assembly. Cut or bend the metal bracket to prevent interference with the hazard warning switch as shown (see Figure 2). CAUTION: Make sure no trimmed pieces fall onto the HVAC/audio head.

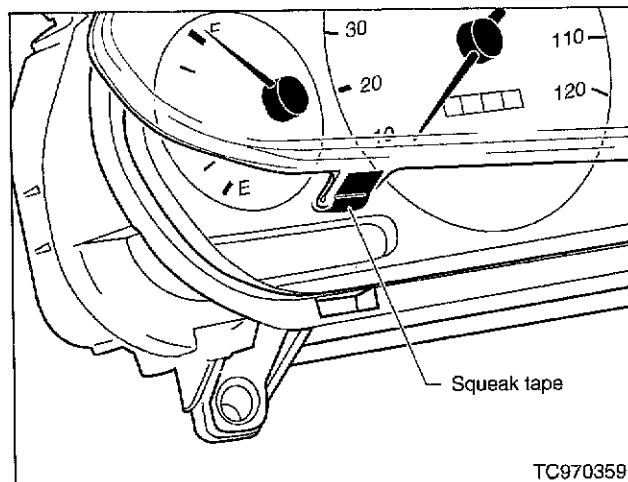
Figure 3

Item	Incident Part	Incident Description	Production C/M Date/VIN	Repair Method
3	Instrument housing and cover	The fit is loose between the clear plastic tab and the housing slot.	August 1, 1995 TT122422, TT710674, TM400038	Remove the instrument cluster bezel. Add squeak tape to the clear plastic tabs as shown (see Figure 3). NOTE: Use a dry cloth to wipe clean the inside of the instrument cover.

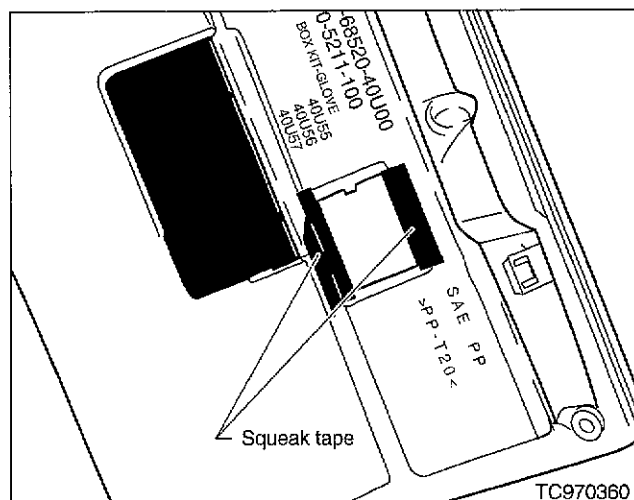
Figure 4

Item	Incident Part	Incident Description	Production C/M Date/VIN	Repair Method
4	Glove box lamp housing	The fit is loose between the lamp housing and the glove box.	October 30, 1996 VT824796, BT211431, VM506150	Remove the glove box. Remove the lamp housing. Add squeak tape to the opening for the lamp housing as shown (see Figure 4).

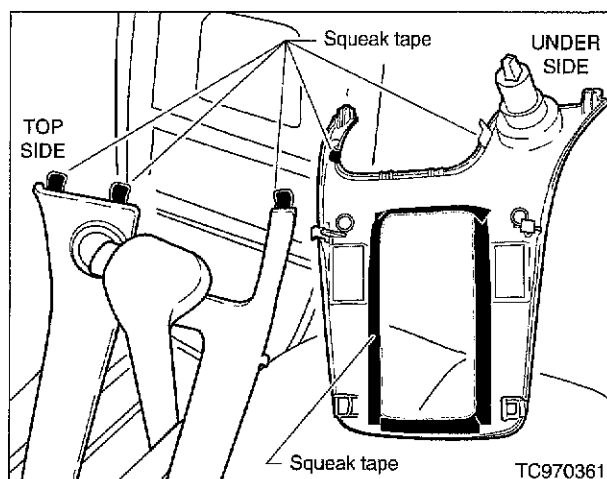
Figure 5

Item	Incident Part	Incident Description	Production C/M Date/VIN	Repair Method
5	A/T shifter finisher	The A/T shifter finisher contacts the A/T shift indicator bezel.	None	Remove the A/T shifter finisher. Add squeak tape to underside of the A/T shifter finisher in two different areas as shown. Also add squeak tape to the topside tabs as shown (see Figure 5).

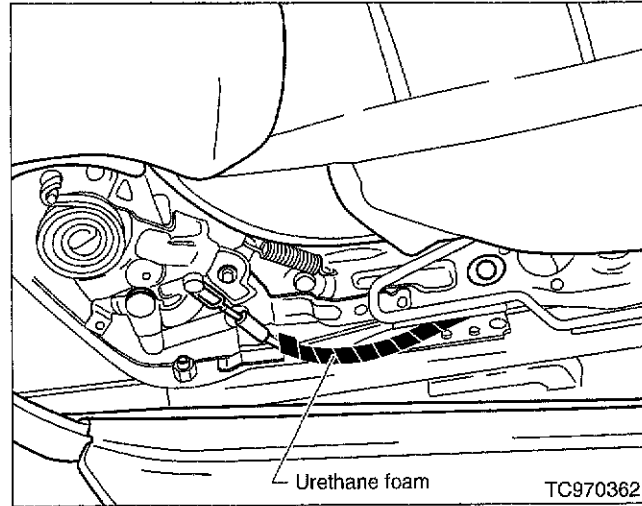
Figure 6

Item	Incident Part	Incident Description	Production C/M Date/VIN	Repair Method
6	Passenger side seat recliner cable Manual passenger seat only	Passenger side seat recliner cable contacts the side cushion finisher.	None	Remove the lower seat finisher. Wrap urethane foam around the recliner cable as shown (see Figure 6).

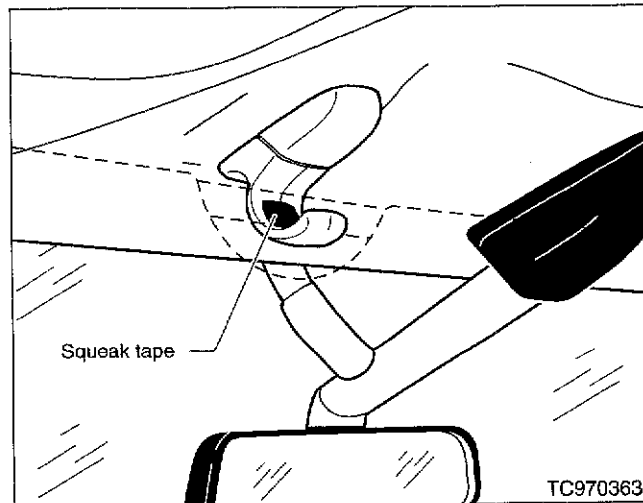
Figure 7

Item	Incident Part	Incident Description	Production C/M Date/VIN	Repair Method
7	Sun visor	Excessive clearance between the sun visor holder clip and the sun visor rod.	None	Add squeak tape to the bottom of the inside of the clip as shown (see Figure 7).

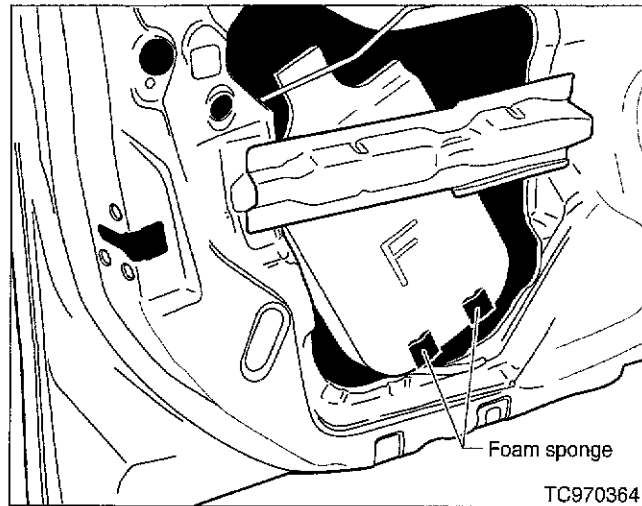
Figure 8

Item	Incident Part	Incident Description	Production C/M Date/VIN	Repair Method
8	Front door styrofoam side impact absorber	The fit is loose between the ribs on the styrofoam block and the inner door panel.	April 25, 1997 VT865191, VT220646 May 16, 1997 VM532102	Remove the door finisher. Remove the side impact absorber. Add foam sponge to the ribs of the impact absorber as shown (see Figure 8). Reinstall the absorber.

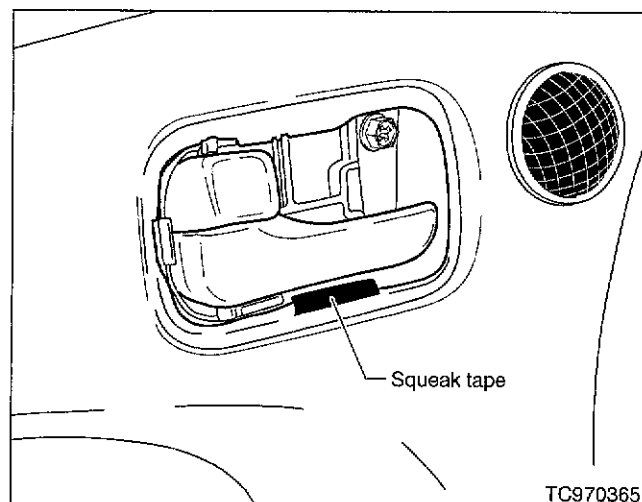
Figure 9

Item	Incident Part	Incident Description	Production C/M Date/VIN	Repair Method
9	Inside door handle finisher	The fit is loose between the inside door handle finisher and the opening for the finisher.	None	Remove the door handle finisher. Wrap squeak tape over the door finisher as shown (see Figure 9).

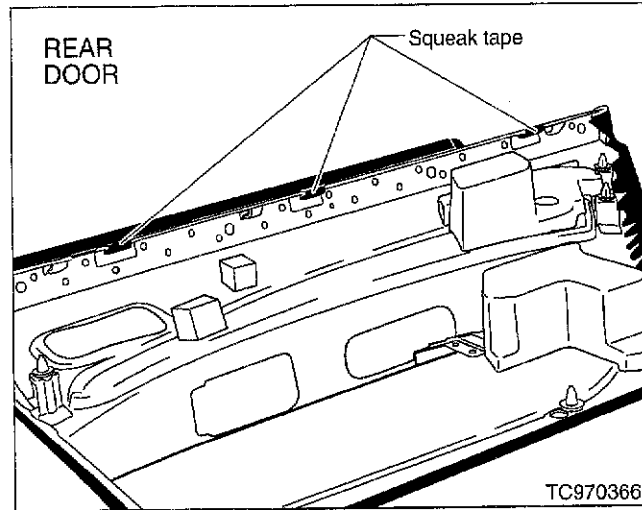
Figure 10

Item	Incident Part	Incident Description	Production C/M Date/VIN	Repair Method
10	Door finisher All	At the window sill area, the existing squeak tape is too thin resulting in a squeak noise when the door finisher rubs against the door inner panel.	August 1, 1995 TT706072, TT104632, TM400038	Remove the door finisher. Remove the existing squeak tape from the three raised areas of the door finisher. Replace with two layers of the squeak tape recommended in this bulletin (see Figure 10).

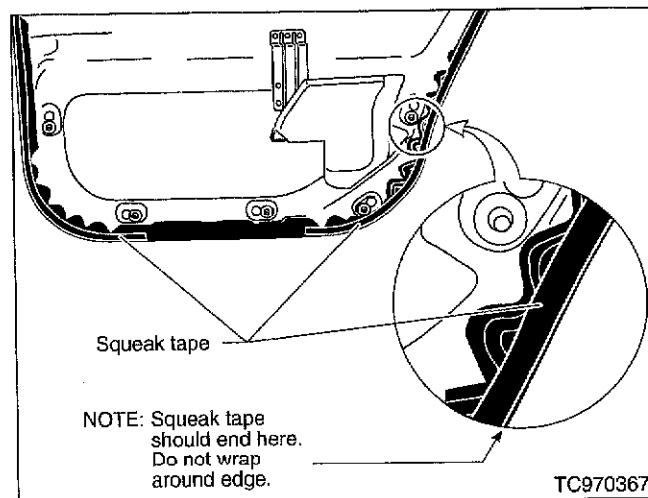
Figure 11

Item	Incident Part	Incident Description	Production C/M Date/VIN	Repair Method
11	Rear door finisher	The existing squeak tape is improperly located on the finisher. This allows contact with the door inner panel.	May 27, 1996 TT175769, TT748571, TM424508	Remove the door finisher. Add squeak tape to the contact area as shown (see Figure 11). NOTE: Do not wrap the tape around the door finisher edge. The tape should not be visible from the outside after installation.

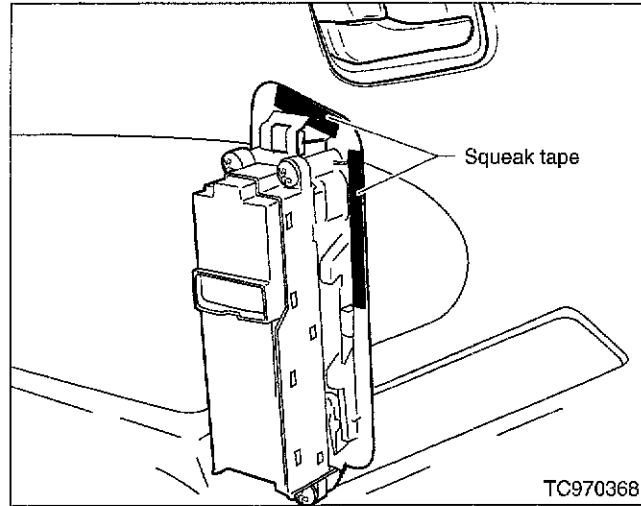
Figure 12

Item	Incident Part	Incident Description	Production C/M Date/VIN	Repair Method
12	Front power window switch finisher	There is intermittent contact between the bottom of the switch finisher and the door finisher.	March 14, 1997 VT854557, VT218791, VM523196	Remove the switch finisher. Add squeak tape to the contact area as shown (see Figure 12).

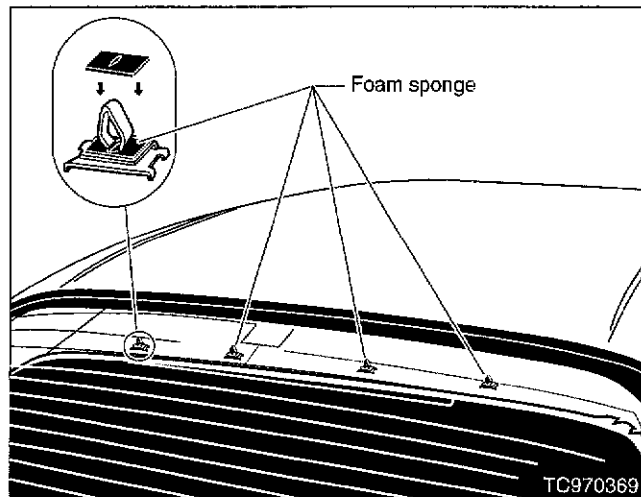
Figure 13

Item	Incident Part	Incident Description	Production C/M Date/VIN	Repair Method
13	Headliner fastener clips	The fit is loose between the headliner fastener clips and the rear window.	February 14, 1997 VT848584, VT218149 April 12, 1997 VM527876	Remove the C-pillar finishers. Carefully pull the headliner down at the rear window. Make squares with the foam sponge (30x30 mm), cut slits in the middle and put over the clips as shown (see Figure 13).

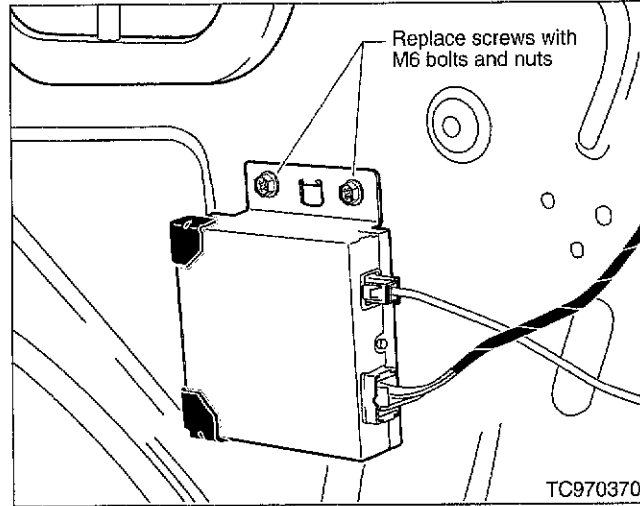
Figure 14

Item	Incident Part	Incident Description	Production C/M Date/VIN	Repair Method
14	Multi-remote lock control unit (LCU05)	Rattle noise near the bottom of the control unit because the screw clamping force is inadequate.	None	Remove the right side trunk finisher. Replace the control unit screws with M6 bolts and nuts (see Figure 14). Torque to specification.

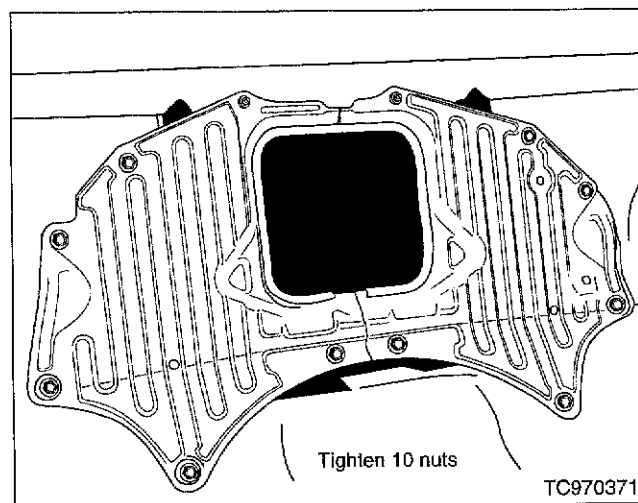
Figure 15

Item	Incident Part	Incident Description	Production C/M Date/VIN	Repair Method
15	Rear seat back support panel nut	The nuts that secure the support panel may be loose. You hear a pop noise when initiating a turn or turning on to an incline (hill or driveway).	October 25, 1995 TT142586, TT731283	Remove the rear seat cushion and back. Torque the 10 nuts to specification (see Figure 15).

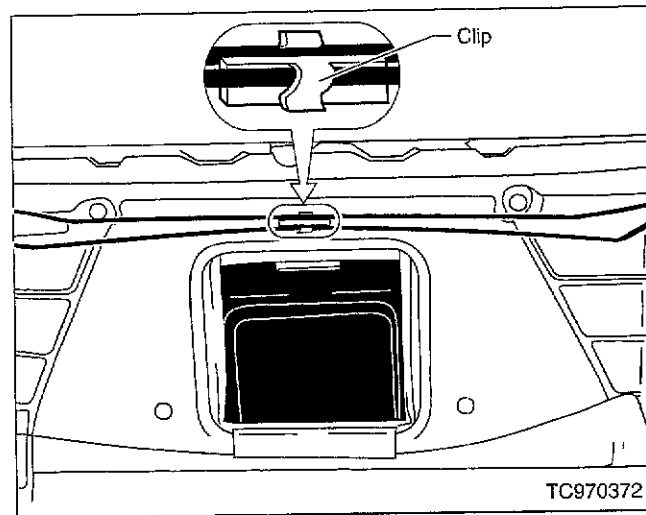
Figure 16

Item	Incident Part	Incident Description	Production C/M Date/VIN	Repair Method
16	Trunk torsion bars	Rattle noise due to intermittent contact between the trunk torsion bars.	October 7, 1996 VT820061, VT208606, VM504366	Add clip (P/N 84437-41L00) to ensure a clearance between the bars (see Figure 16).
