SERVICE BULLETIN

Classification: HA97-015	Reference: NTB97-093	Date: January 1, 1998
-----------------------------	-------------------------	--------------------------

1995-97 MAXIMA, MIL 'ON' OR POOR DRIVEABILITY DUE TO A/C EVAPORATOR CONDENSATION LEAKING ON ECM

APPLIED VEHICLES: All 1995-97 Maxima (A32)

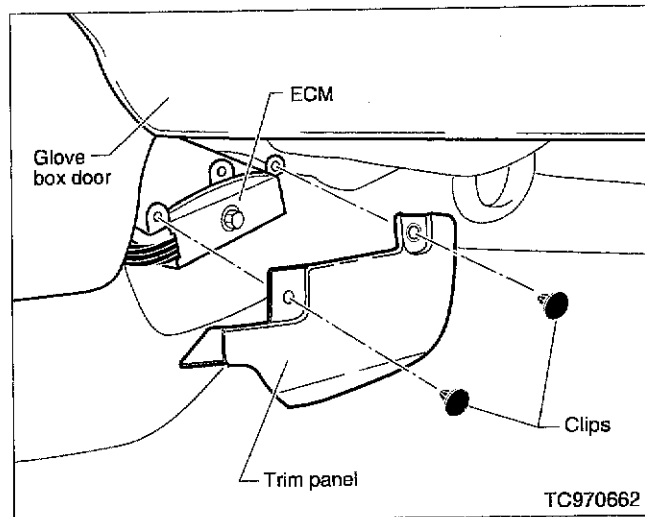
1. Check for wetness and/or mildew on the passenger side carpeting around the ECM area and check the ECM for signs of water damage (see Figure 1 for ECM location).
 - A. If the carpeting is dry and mildew-free around the area of the ECM and there are no signs of water damage (wetness, water spots, corrosion, etc.) to the ECM, use the service manual to diagnose the incident DTCs.
 - B. If the carpeting is wet and/or mildew is present around the ECM and the ECM has signs of water damage (wetness, water spots, corrosion, etc.), proceed with step 2.

2. Replace the water damaged ECM with the correct service part number (see Figure 1).
