SERVICE BULLETIN

BT97-031

1995-98 MAXIMA SUNROOF WATER LEAKS DUE TO REAR DRAIN TRAY GUIDE

APPLIED VEHICLE: All 1995-98 Maxima (A32)

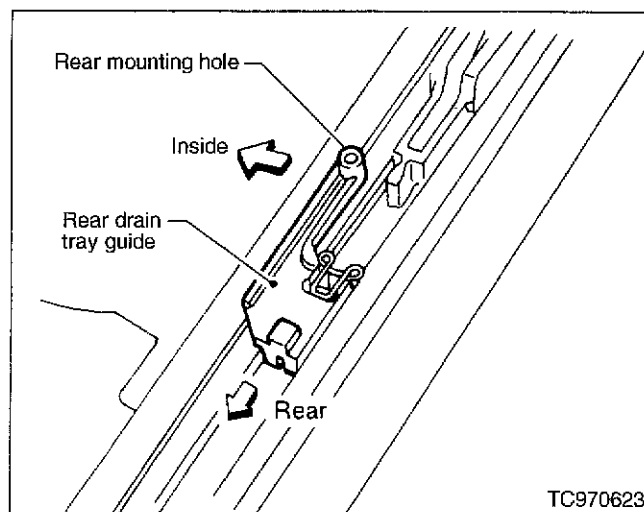
Figure 1

If a 1995-98 Maxima exhibits sunroof water leaks, the cause may be an improperly positioned sunroof rear drain tray that may be from broken drain tray guide(s).

Replace drain tray guide(s) according to service procedures outlined in the appropriate service manual:

- For 1995 Maxima, see pages BF-33 through BF-35 of the 1995 Maxima Service Manual.
- For 1996 Maxima, see pages BT-28 through BT-30 of the 1996 Maxima Service Manual.
- For 1997 Maxima, see pages BT-32 through BT-34 of the 1997 Maxima Service Manual.
- For 1998 Maxima, see pages BT-34 through BT-36 of the 1998 Maxima Service Manual.
