SERVICE BULLETIN

Classification: EC97-050	Reference: NTB98-024	Date: March 15, 1998
-----------------------------	-------------------------	-------------------------

DIAGNOSTIC PROCEDURE FOR DTCs P0120, P0510, P0731, P0732 OR P0733 WITH NO DRIVEABILITY INCIDENTS

APPLIED VEHICLES:	1995-96	Maxima	(A32)
	1995-97	Sentra/200SX	(B14) with the SR20 engine
	1996-97	Truck	(D21)
	1995-97	Altima	(U13)
	1996-97	Pathfinder	(R50)
	1995-96	240SX	(S14)
	1996-97	Quest	(V40)

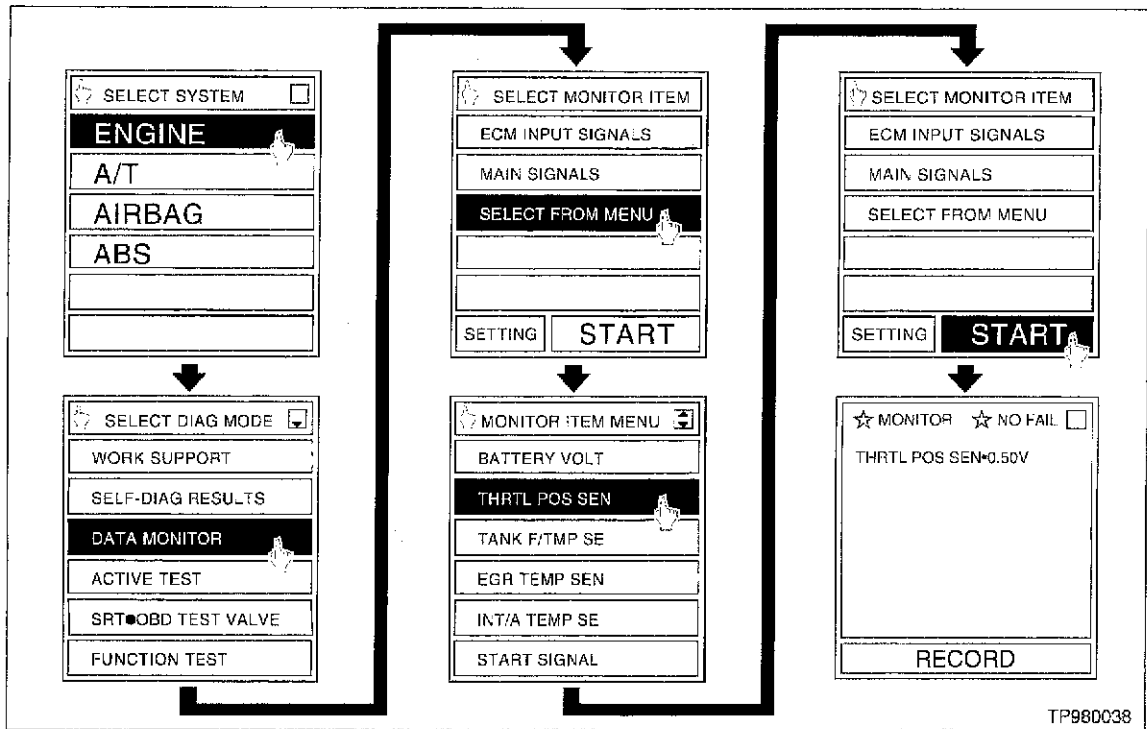
Figure 1

1. Start the vehicle and warm up the engine (coolant temperature above 160°F).
2. Shut the engine off. Then turn the key to the ON position.
3. Using CONSULT, select THRTL POS SEN in the Data Monitor mode (see Figure 1, page 2).
4. Note the TPS voltage (initial resting voltage).
5. Depress the accelerator fully and then release slowly until it releases completely.
6. Wait 5 seconds and monitor the TPS voltage again (final resting voltage). Note any change.

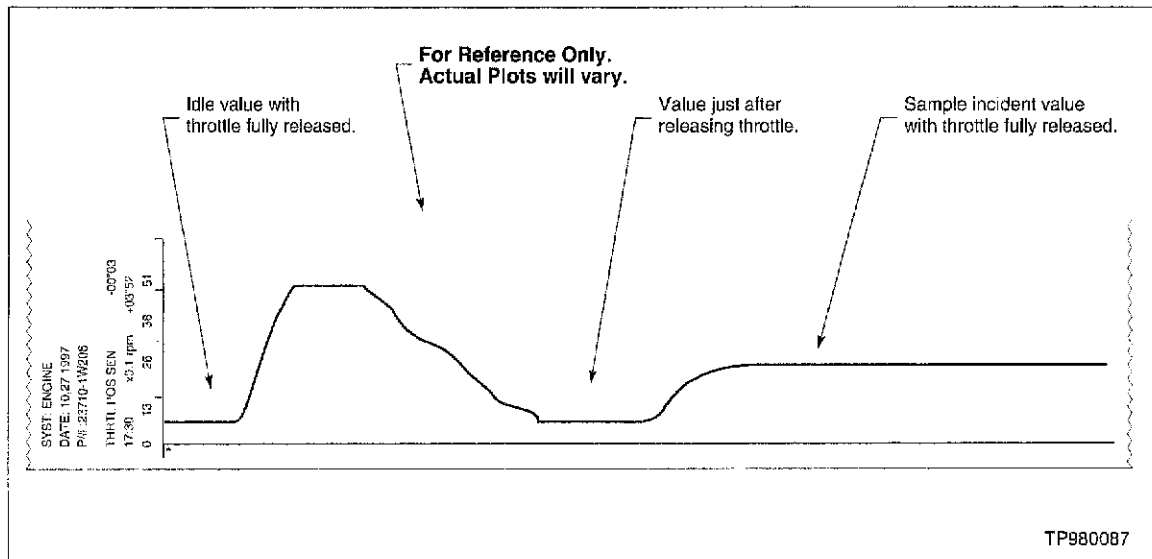
- A) If the final resting voltage is greater than the initial resting voltage, proceed to step 7.
- B) If there is no measurable difference between the initial and final resting voltages, refer to the specific DTC code diagnostic procedure in the appropriate service manual.

NOTE: Figure 2 is a visual representation of the incident and is **for reference only**. It will be easier to perform this test based on the actual voltage values displayed (as in Figure 1) rather than to graph the voltage output. *Use the actual voltage values to calculate the change.*

7. Use the appropriate service manual procedures to replace the TPS with the countermeasure TPS. Also replace the automatic transmission control unit.

7. Use the appropriate service manual procedures to replace the TPS with the countermeasure TPS.
