SERVICE BULLETIN

Classification: EC97-050a	Reference: NTB98-024a	Date: August 1, 1998
------------------------------	--------------------------	-------------------------

DIAGNOSTIC PROCEDURE FOR DTCs P0120, P0510, P0731, P0732 OR P0733 WITH NO DRIVEABILITY INCIDENTS

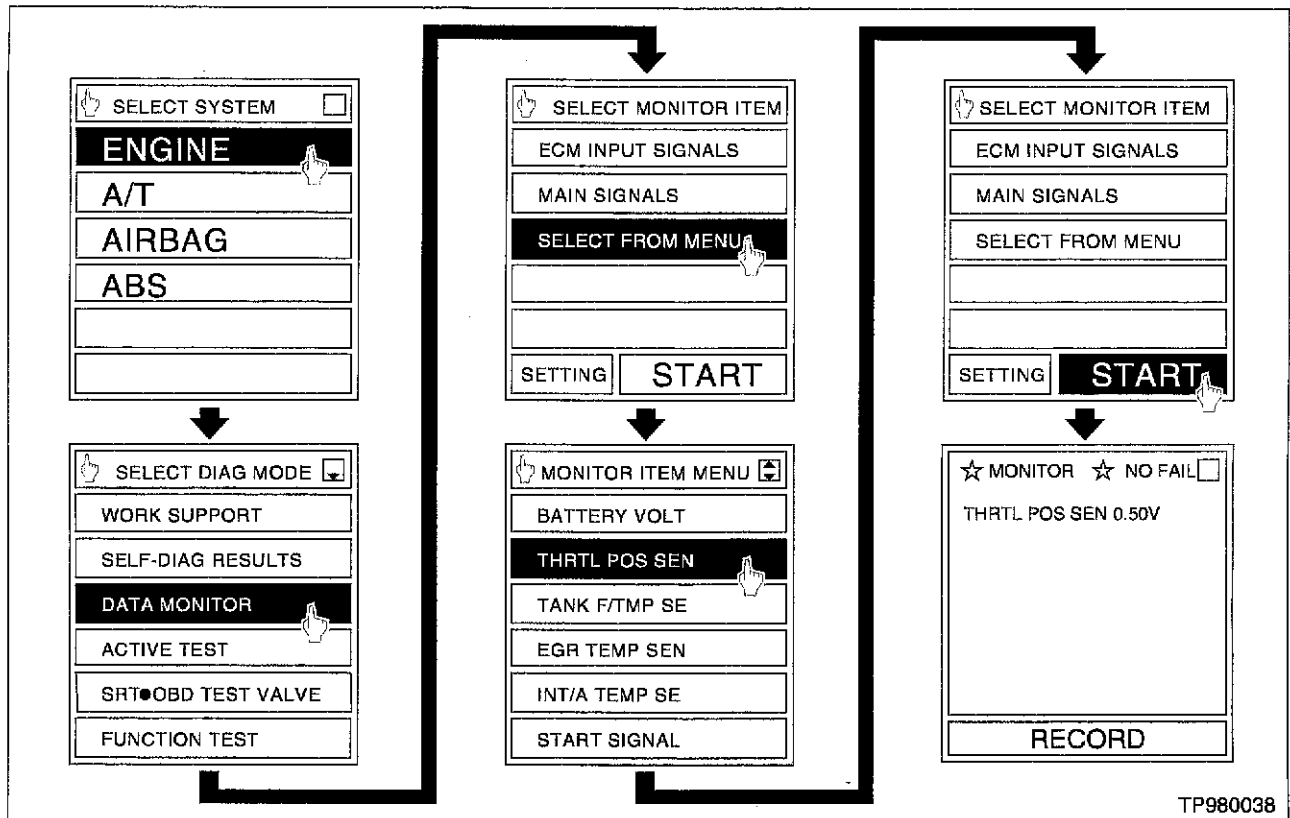
Figure 1

1. Start the vehicle and warm up the engine (coolant temperature above 160°F).
2. Shut the engine off. Then turn the key to the ON position.
3. Using CONSULT, select THRTL POS SEN in the Data Monitor mode (see Figure 1, page 2).
4. Note the TPS voltage (initial resting voltage).
5. Depress the accelerator fully and then release slowly until it releases completely.
6. Wait 5 seconds and monitor the TPS voltage again (final resting voltage). Note any change.

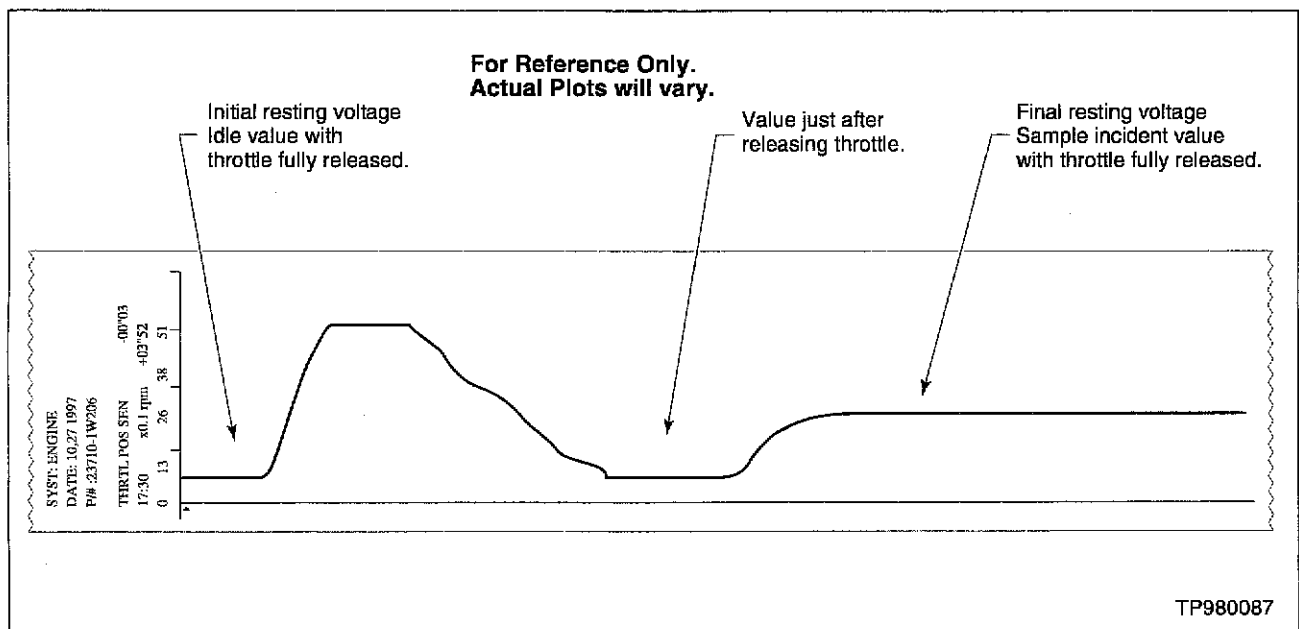
- A) If the final resting voltage is greater than the initial resting voltage, proceed to step 7.
- B) If there is no measurable difference between the initial and final resting voltages, refer to the specific DTC code diagnostic procedure in the appropriate service manual.

NOTE: Figure 2 is a visual representation of the incident and is **for reference only**. It will be easier to perform this test based on the actual voltage values displayed (as in the last frame of Figure 1) rather than to graph the voltage output. *Use the actual voltage values to monitor the voltage change.*

7. Use the appropriate service manual procedures to replace the TPS with the countermeasure TPS. Also replace the automatic transmission control unit.

7. Use the appropriate service manual procedures to replace the TPS with the countermeasure TPS.

CAUTION: Pay close attention to the TPS adjustment and resetting the Self Learning of the idle position memory. After installation, if you adjust the new TPS incorrectly you may create additional MIL 'on' or driveability issues.
