# SERVICE BULLETIN

Classification: BT95-003	Reference: NTB95-041	Date: June 7, 1995
-----------------------------	-------------------------	-----------------------

## 1995 MAXIMA SUPPLEMENT RESTRAINT SYSTEM (SRS) FLASHING LIGHT

**APPLIED VEHICLE:** 1995 Maxima (A32)

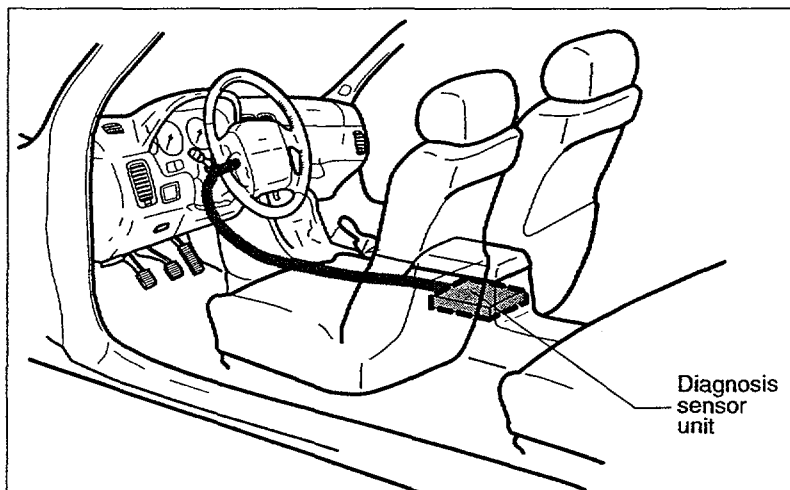
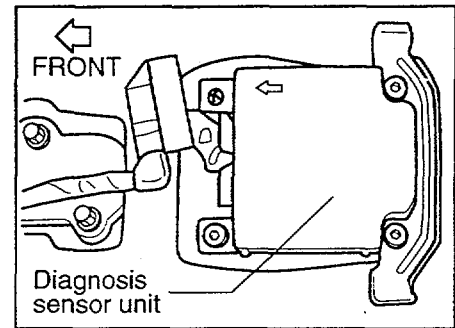
When diagnosing a blinking SRS warning light (with a blinking frequency of 0.5 seconds on/0.5 seconds off *or* 3 seconds on/2 seconds off), the attached diagnostic fault tree should be followed especially when CONSULT indicates no failure detected.

**NOTE:** The SRS warning light is activated if the driver door switch goes through an open and close cycle 5 times in the 7 seconds after the key is turned on.

Refer to the flowchart on page 2. Perform the following repair(s) as necessary:

1. Repair the battery/charging system. It is possible that during engine cranking with a partially discharged battery (interior lights left on, etc.), battery voltage may momentarily drop below 7.6 volts and trigger the flashing light. Verify the battery and charging system is operating normally.
2. Adjust/repair the driver door switch or adjust the door latch.
3. To replace the control unit, remove the console box and replace the SRS diagnosis sensor unit. The service manual procedure is on page BF-50.

**IMPORTANT:** When using CONSULT, be sure to use the BACK key to return to user mode. If this is not done, the "AIR BAG" warning lamp will continue to flash after the ignition is turned on. The service manual procedure is on page BF-61.
