# SERVICE ADVISORY

Classification: AT95-005a	Reference: NTB95-109a	Date: December 6, 1995
------------------------------	--------------------------	---------------------------

## TRANSMISSION FLUID COOLER CLEANING

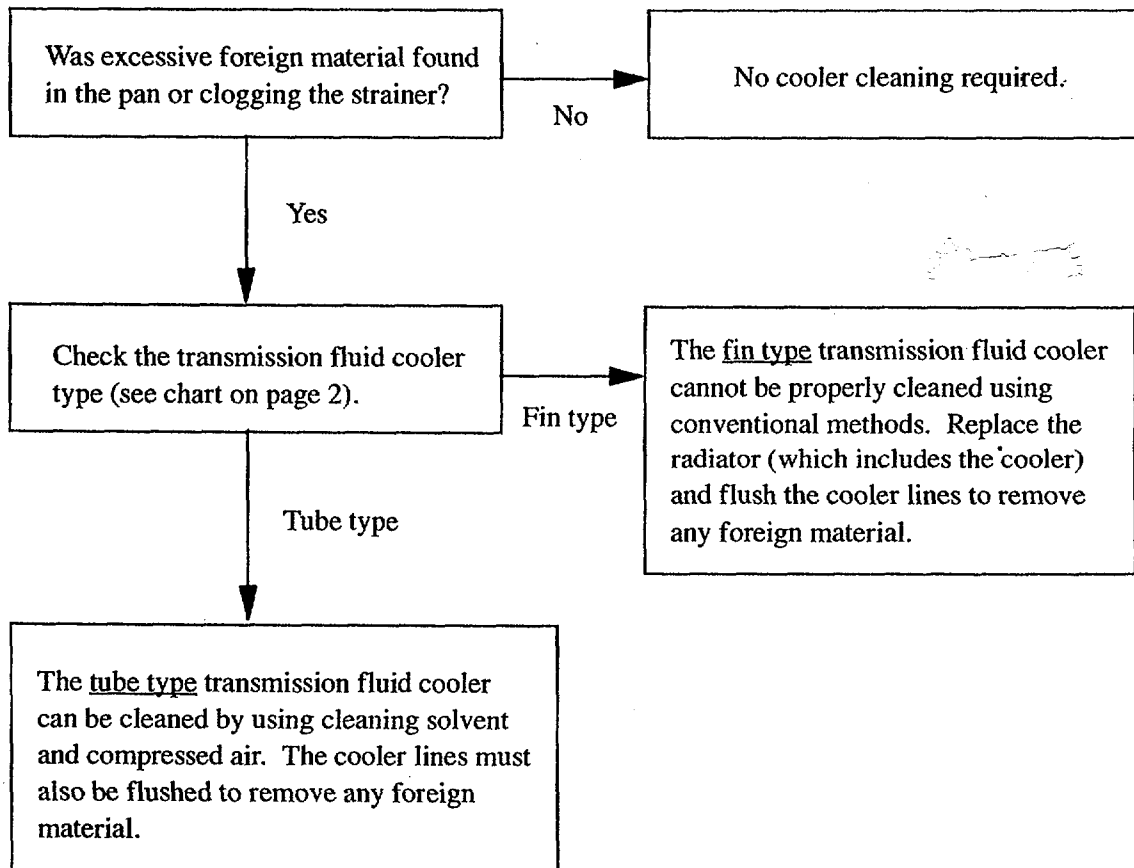
When an automatic transmission is repaired, use the following flowchart to determine the type of procedure to follow for cleaning the transmission fluid cooler.

**NOTE:** A clogged cooler may result in a subsequent failure of the planetary gears in a new or rebuilt transmission.
